**SAS Superstructure**

Location: 04-SF-80-13.2 / 13.9

Daily Diary Report by Bid Item

04-03-13, Tuesday, Mostly Cloudy, 51-78F, Humidity 71% - Cable Suspender Rope Paint (North Main Span) & Separator Installation / Painting

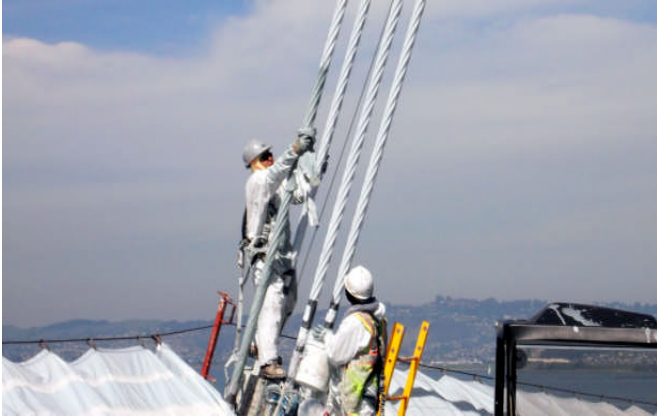
N82 - NW rope should not be painted before repair holidays, Manny run first 10 ft of Blue Gray and stopped by me.

- * Went to Field, talked to QA - Rex, he told me that the inspection results on Pegalink coating: paint damaged at N82 - NW rope, N88 - SW rope two rope needed touch up work. And N82, N84 & N86 top ropes area need to be cleaned out. Crew (three painters) prepared for Blue Gray coating operation on N76 to N88. Manny mixed 4 barrels of Noxyde:Blue Gray paint with Batch # M28143. They also performed cleaning equipment and waiting for checking results in order to start the blue gray coating operation.

- * 1st Blue Gray coating operation started on NPP76 at 13:15 PM, and operation ended at 16:20 PM on NPP82. During operation, crew reset the spray heads & repaint the rope serverial times due to holidays on the back of ropes (see inspection list for details). Again, N82 - NW rope & N88 - SW rope were not painted due to damaged pegalink paint, will repair tomorrow by touch up the haliday area by pegalink paint then Blue Gray paint next. The top rope areas N82, N84 & N86 area will be cleaned later on.

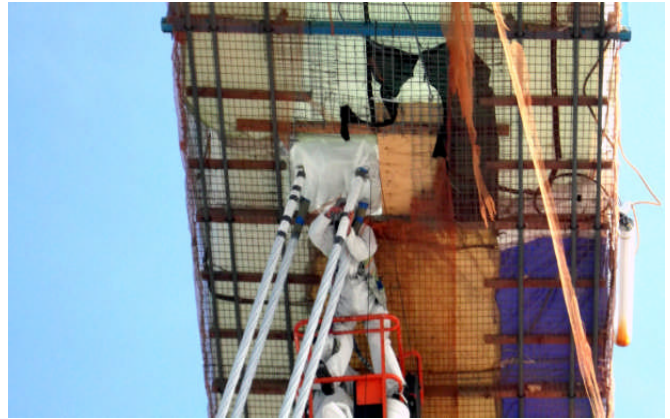
Painter Jorge & Danial wrapped up bear tope ropes with plastic at N84 & N86 area

- * At 11:00 AM, painters Jorge & Danial were in top of the rope (N86) to wrap up the top area using plastic, also N84 as well, they are going deal the top rope area later on. They completed wrapping N84 & 86 at 11:25 AM.
